<b>Test Report No</b> ELN22090283	<b>ULR No.</b> TC576222000000473F	<b>QR Code (Test Report)</b>	<b>QR Code (Certificate)</b>

<b>Name of Customer</b>	Leo Lights
<b>Address of Customer</b>	Om Industrial Estate, Vadolgaon, Behind Gnp Galaxy Mall, Near Reliance Petrol Pump Ambernath(W)
<b>Name of Manufacturer</b>	Leo Lights
<b>Brand Name</b>	--
<b>Name of Sample/ Model No./ Sample No.</b>	SL004 Street Light 50W Without Lens
<b>Statement of Conformity</b>	NA
<b>Product Rating</b>	230Vac, 50Hz, 50W
<b>Test Location</b>	At Lab
<b>Tested By</b>	
<b>Reviewed By</b>	
<b>Authorised By</b>

Sr. No.	Test Name	Test Standard	Page. No.
1	Photometry & Colorimetry Test	IES LM 79: 2008	2 of 10
2	Ingress Protection Test	IS 10322 (Part 1): 2014, Cl. No. 9.2	7 of 10
3	Impact test	IEC 62262:2002, Clause No. 6	9 of 10

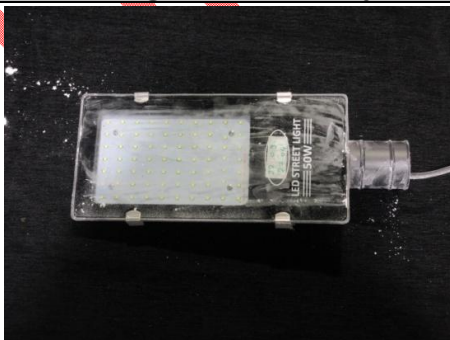
- Tests according to clauses.....	9.2.2 & 9.2.7	--
	- electric strength test afterwards	Withstood	P
	a) no deposit in dust-proof luminaire		N/A
	b) no talcum in dust-tight luminaire	Complied	P

##### 1. No ingress of Solid Objects

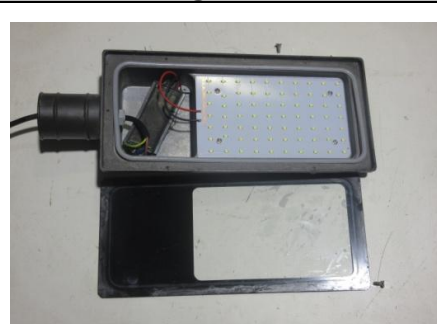
c) no trace of water on current-carrying parts or on insulation where it could become a hazard	No trace of water on current carrying parts or on insulation	P

d) i) For luminaires without drain holes – no water entry	Satisfactory	P
	e) no water in watertight luminaire		N/A
	f) no contact with live parts (IP 2X)		N/A

##### 2. No ingress of water

**1.3 Conclusion:** The result of the test were in compliance with the requirements in the test standard.

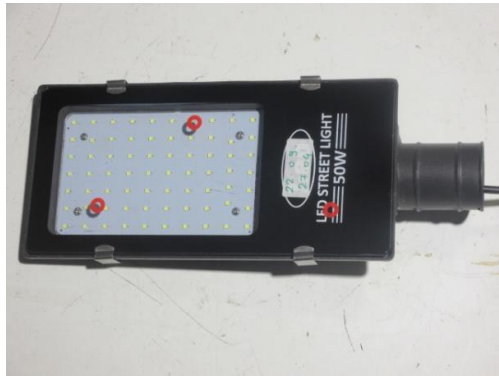
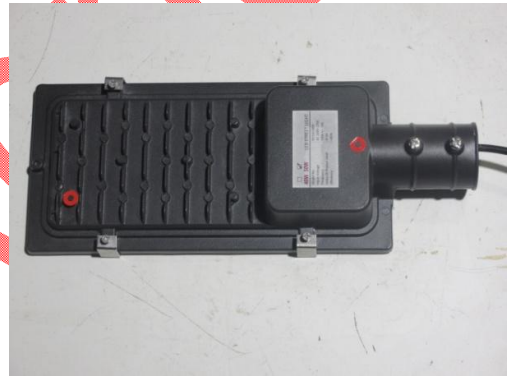
**After Impact**

The sample under test withstood without any visual damage after applying impact of IK07

**1.6. Conclusion:** After the test, there was no damage, no deformation, and no access to live parts.
