<b>Test Report No</b> ELN22090285	<b>ULR No.</b> TC576222000000475F	<b>QR Code (Test Report)</b>	<b>QR Code (Certificate)</b>

<b>Name of Customer</b>	Leo Lights
<b>Address of Customer</b>	Om Industrial Estate, Vadolgaon, Behind Gnp Galaxy Mall, Near Reliance Petrol Pump Ambernath(W)
<b>Name of Manufacturer</b>	Leo Lights
<b>Brand Name</b>	--
<b>Name of Sample/ Model No./ Sample No.</b>	Bent FLDC 001 Flood Light 30W
<b>Statement of Conformity</b>	NA
<b>Product Rating</b>	230Vac, 50Hz, 30W
<b>Test Location</b>	At Lab
<b>Tested By</b>	
<b>Reviewed By</b>	
<b>Authorised By</b>

#### Name of Test: Photometry Test Report

**Name of Test: Ingress Protection Test Report**

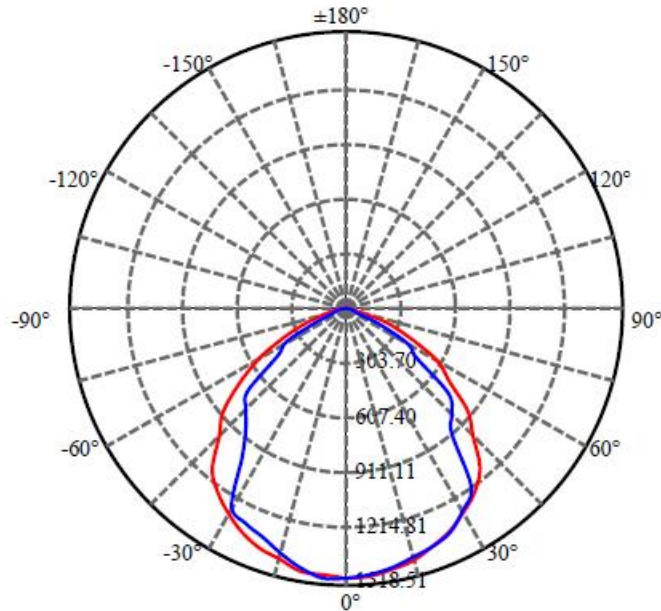
**Light Distribution Curve**

Vert. Spread: 108.4

Horiz. Spread: 96.2

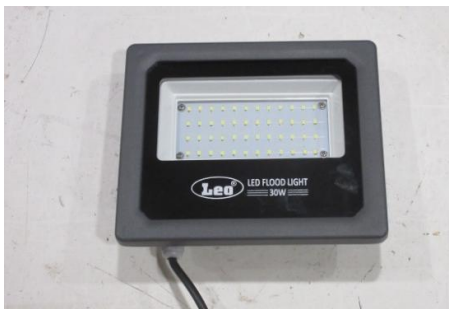
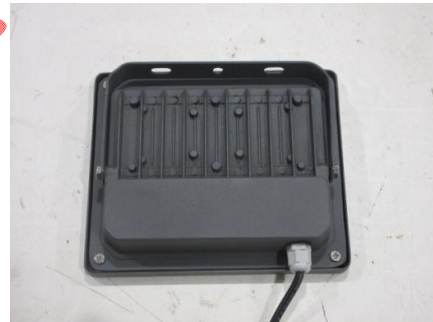
#### Photographs (before testing)

- Classification according to IP.....	IP 66	P
	- mounting position during test.....	Normal Position	--
	- fixing screws tightened; torque (Nm).....	--	--

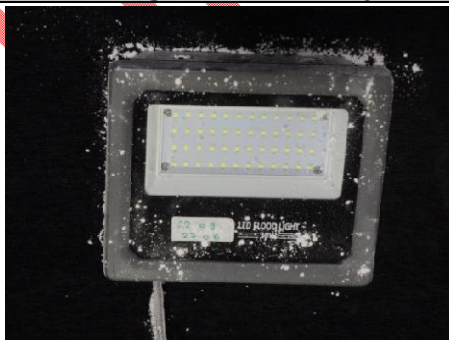
- Tests according to clauses.....	9.2.2 & 9.2.7	--
	- electric strength test afterwards	Withstood	P
	a) no deposit in dust-proof luminaire		N/A
	b) no talcum in dust-tight luminaire	Complied	P

##### 1. No ingress of Solid Objects

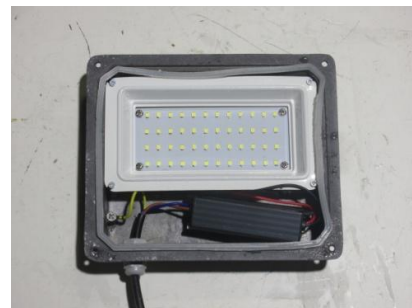
c) no trace of water on current-carrying parts or on insulation where it could become a hazard	No trace of water on current carrying parts or on insulation	P

d) i) For luminaires without drain holes – no water entry	Satisfactory	P
	e) no water in watertight luminaire		N/A
	f) no contact with live parts (IP 2X)		N/A

##### 2. No ingress of water

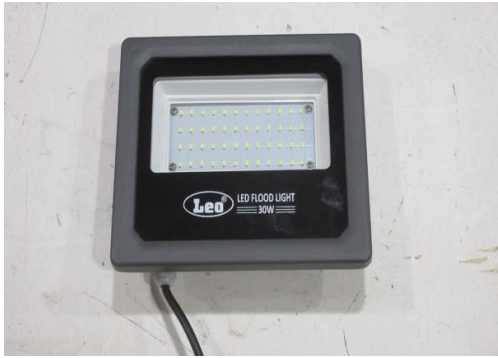
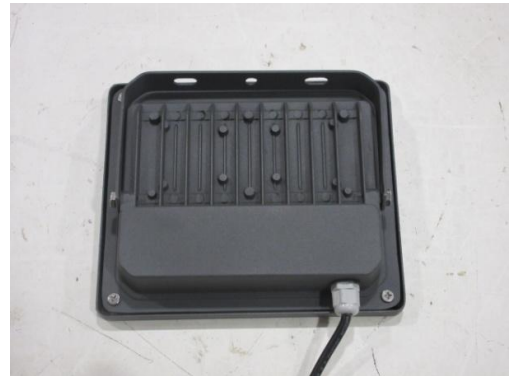
**Before Testing,**

Sr. No.	Parameter	Details
1	IK Test Rating	IK 07
2	Impact Hammer	Vertical Impact Hammer
3	Number of Impacts	3 Impacts on 5 Locations each

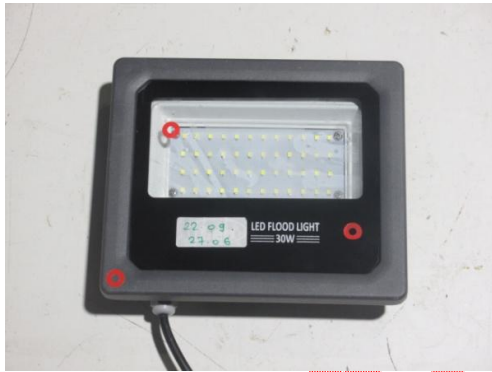
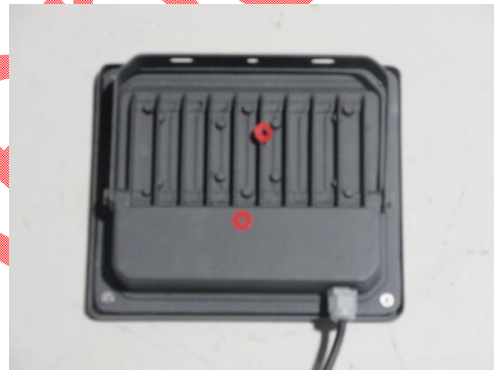
**After Impact**

The sample under test withstood without any visual damage after applying impact of IK07

**1.6. Conclusion:** After the test, there was no damage, no deformation, and no access to live parts.
