Test Report No ELN22090282	ULR No. TC576222000000472F	QR Code (Test Report)	QR Code (Certificate)

Name of Customer	Leo Lights
Address of Customer	Om Industrial Estate, Vadolgaon, Behind Gnp Galaxy Mall, Near Reliance Petrol Pump Ambarnath(W)
Name of Manufacturer	Leo Lights
Brand Name	--
Name of Sample/ Model No./ Sample No.	SL003 Street Light 36W Without Lens
Statement of Conformity	NA
Product Rating	230Vac, 50Hz, 36W
Test Location	At Lab
Tested By	
Reviewed By	
Authorised By

Sr. No.	Test Name	Test Standard	Page. No.
1	Photometry & Colorimetry Test	IES LM 79: 2008	2 of 10
2	Ingress Protection Test	IS 10322 (Part 1): 2014, Cl. No. 9.2	7 of 10
3	Impact test	IEC 62262:2002, Clause No. 6	9 of 10

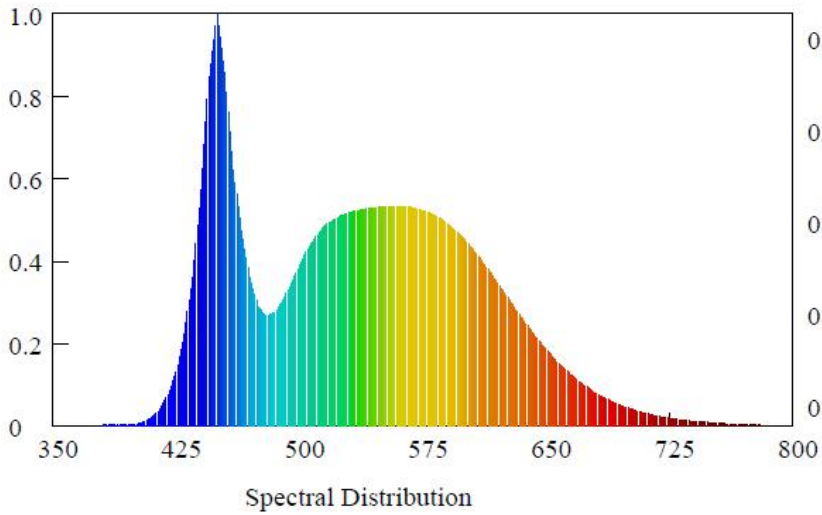
Spectroradiometric Parameters

Colorimetric Graphs

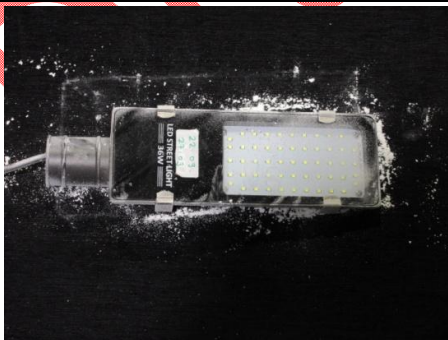
1. No ingress of Solid Objects

- Tests according to clauses.....	9.2.2 & 9.2.7	--
	- electric strength test afterwards	Withstood	P
	a) no deposit in dust-proof luminaire		N/A
	b) no talcum in dust-tight luminaire	Complied	P

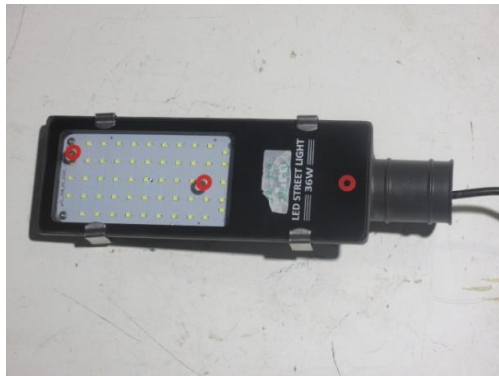
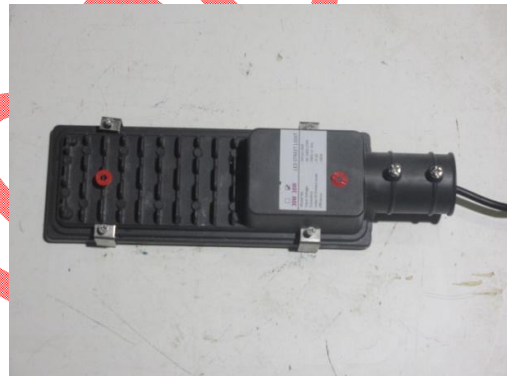
After Impact

The sample under test withstood without any visual damage after applying impact of IK07

1.6. Conclusion: After the test, there was no damage, no deformation, and no access to live parts.
